ROOFER TRAINING

YOU NEED THESE 5 APPS

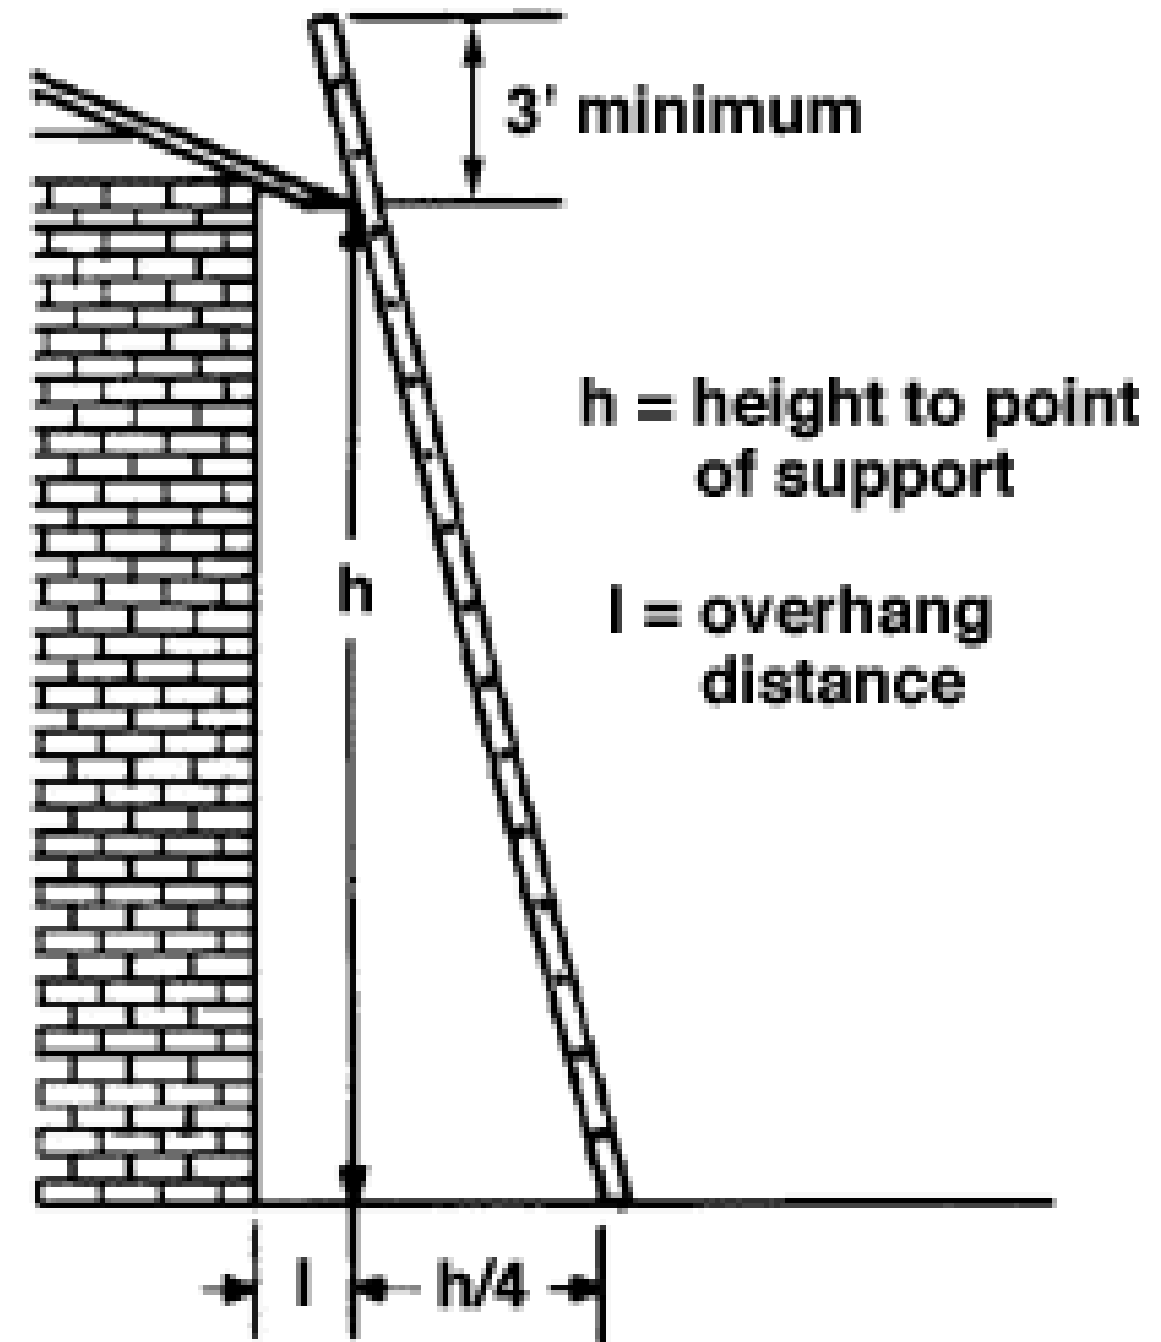
- Purchase ladders that are rated for your weight.
- Ensure that the ladder is properly leveled on solid ground.
- Make sure that the ladder is at the correct angle to the wall. Pay attention to what the ladder is leaning against, as it is easy to mark siding or damage guttering if you're not careful.
- Consider buying electricians' ladders and steps, as these are made of non-conductive fiberglass and will protect you from shocks, should you hit any un-insulated electrical components, such as service conductors.

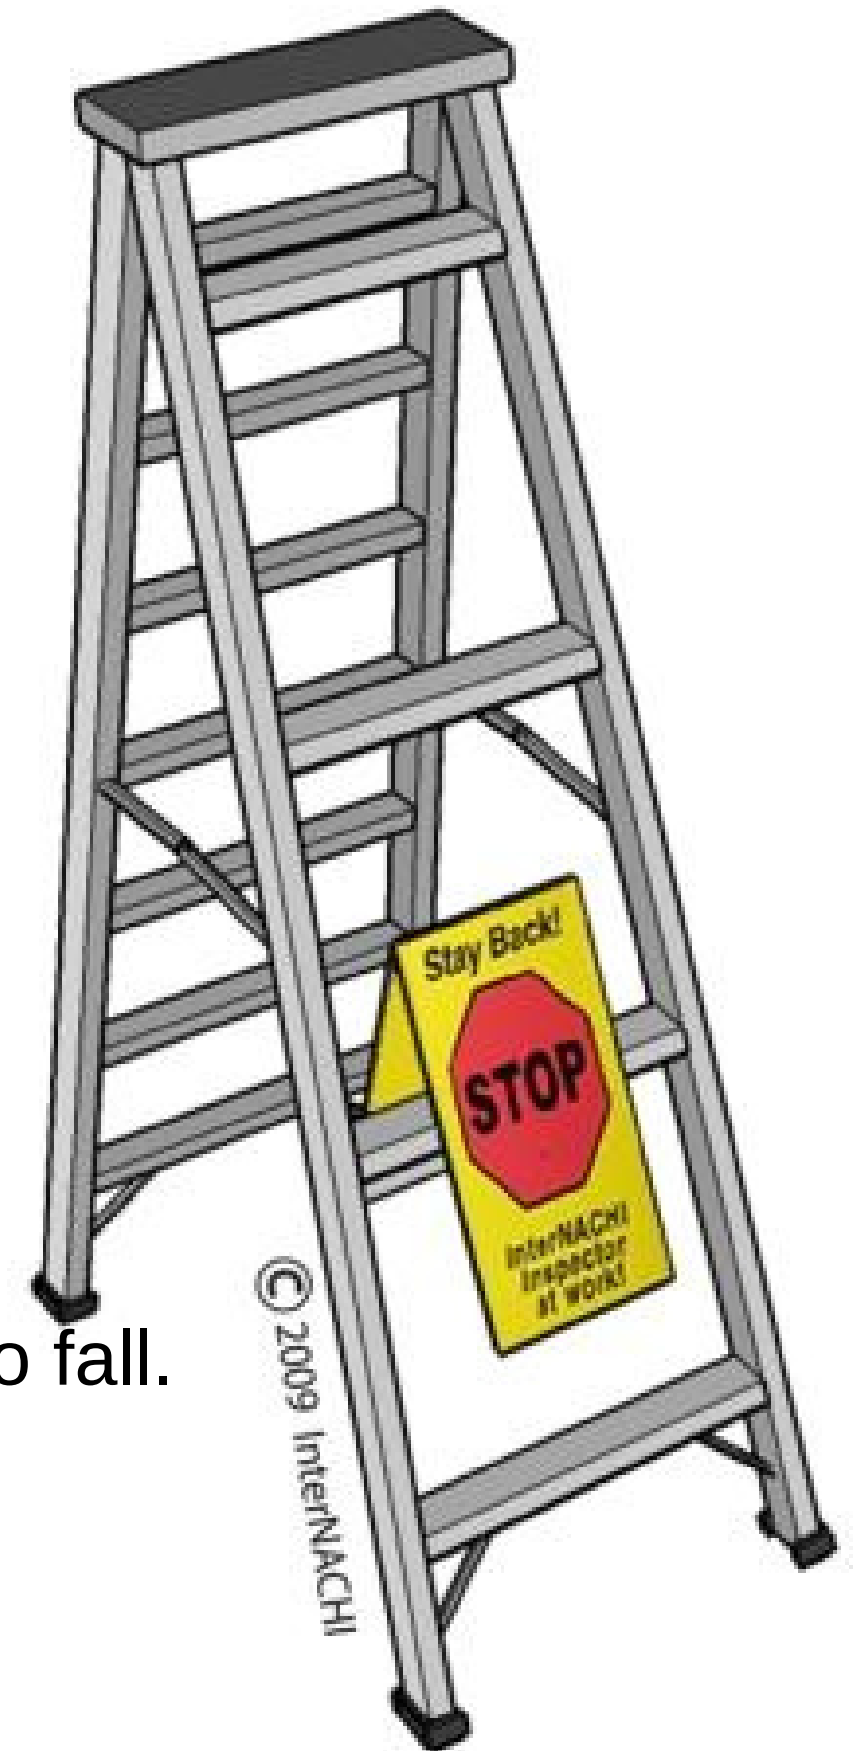
This is a simple process that takes five seconds and ensures that you are about to climb a ladder that is properly pitched.

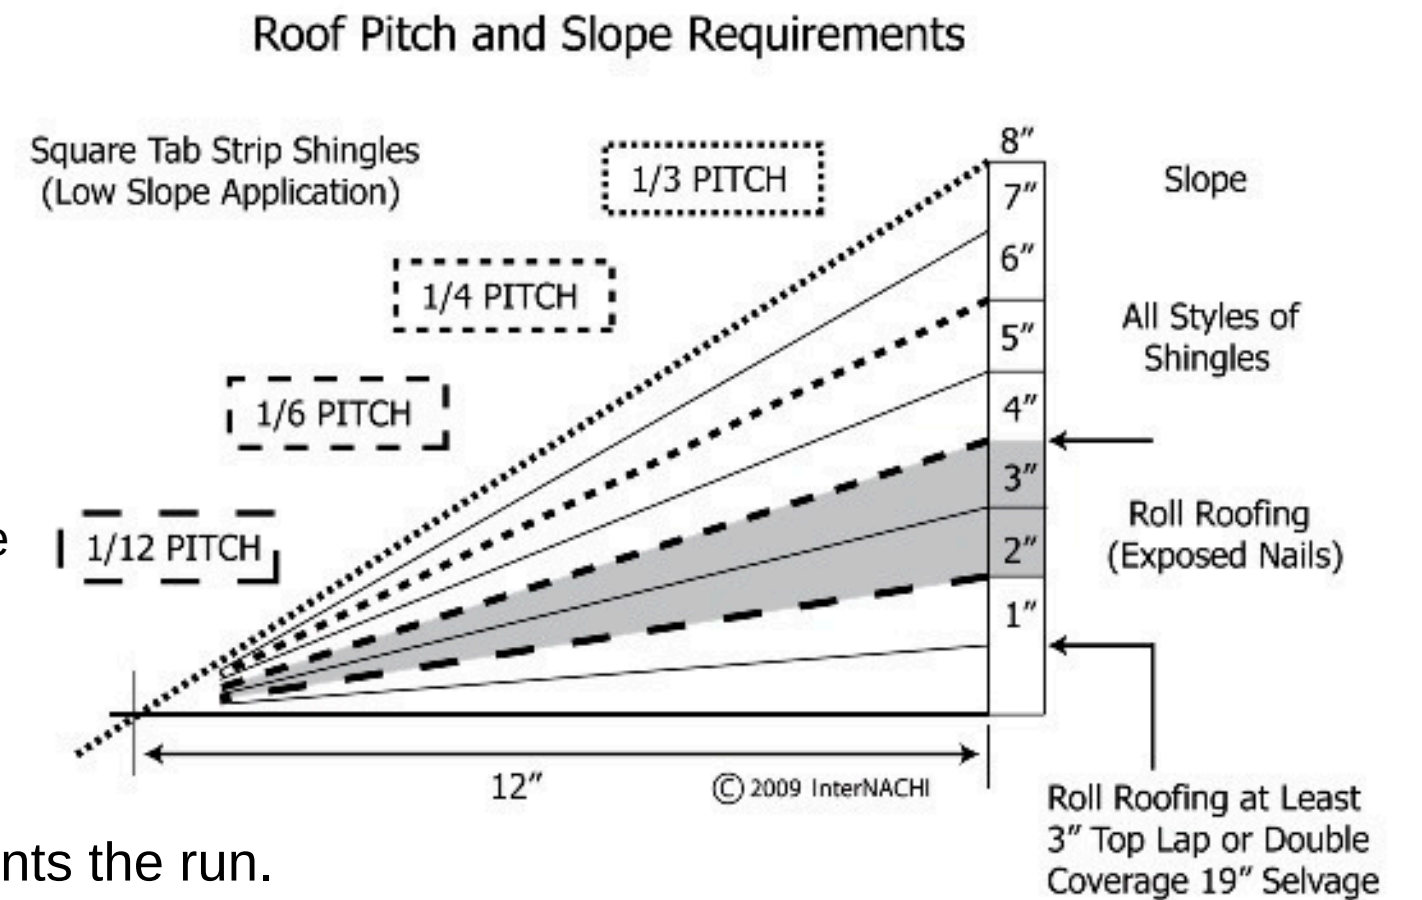
In the diagram above, note that the horizontal figure is 12 inches. This represents the run. The numbers listed to the right, from 1 inch to 8 inches, represents the rise. As the chart shows, a 2&12 roof slope is equal to a 1/12-pitch; a 4&12 roof slope equals a 1/6-pitch; a 6&12 slope equals a 1/4-pitch; and an 8&12 slope equals a 1/3-pitch roof.

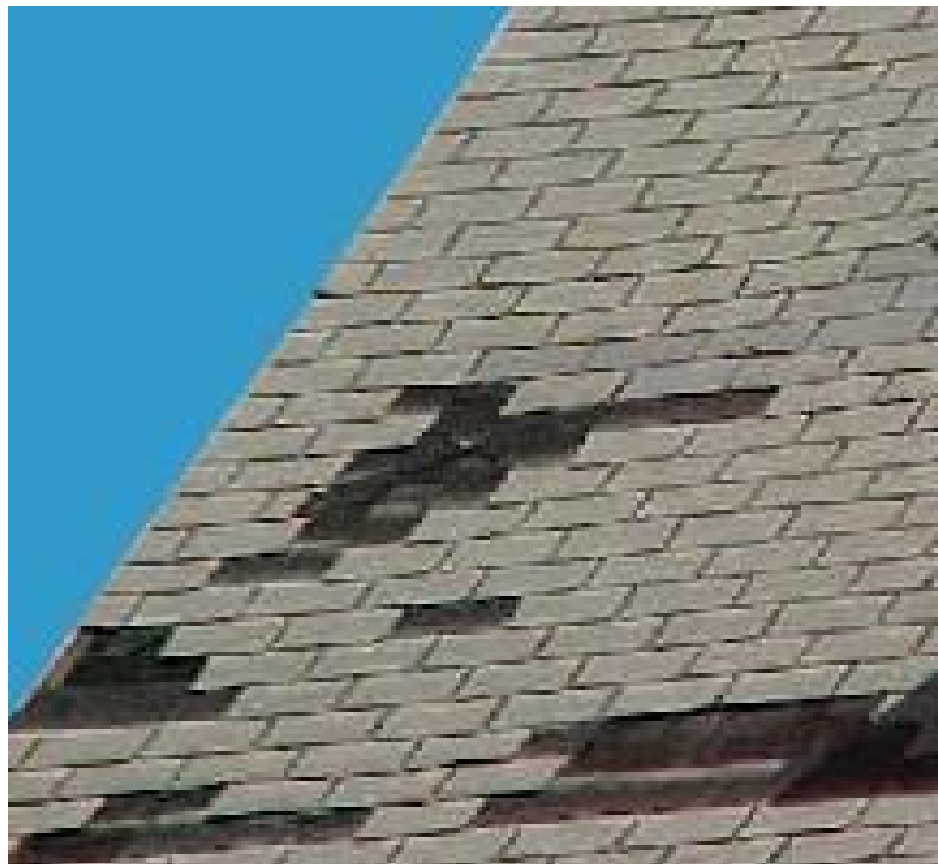
All roof coverings, regardless of materials, are susceptible to additional variables, such as:

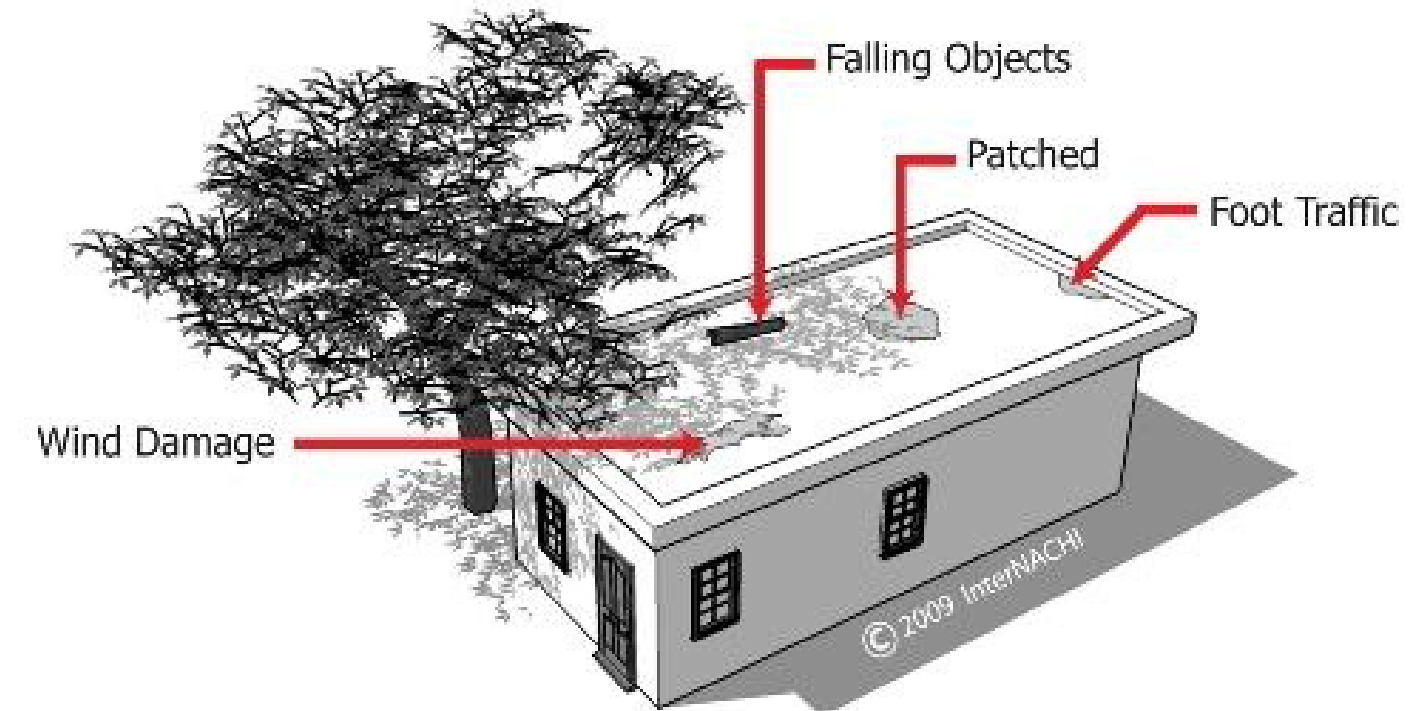
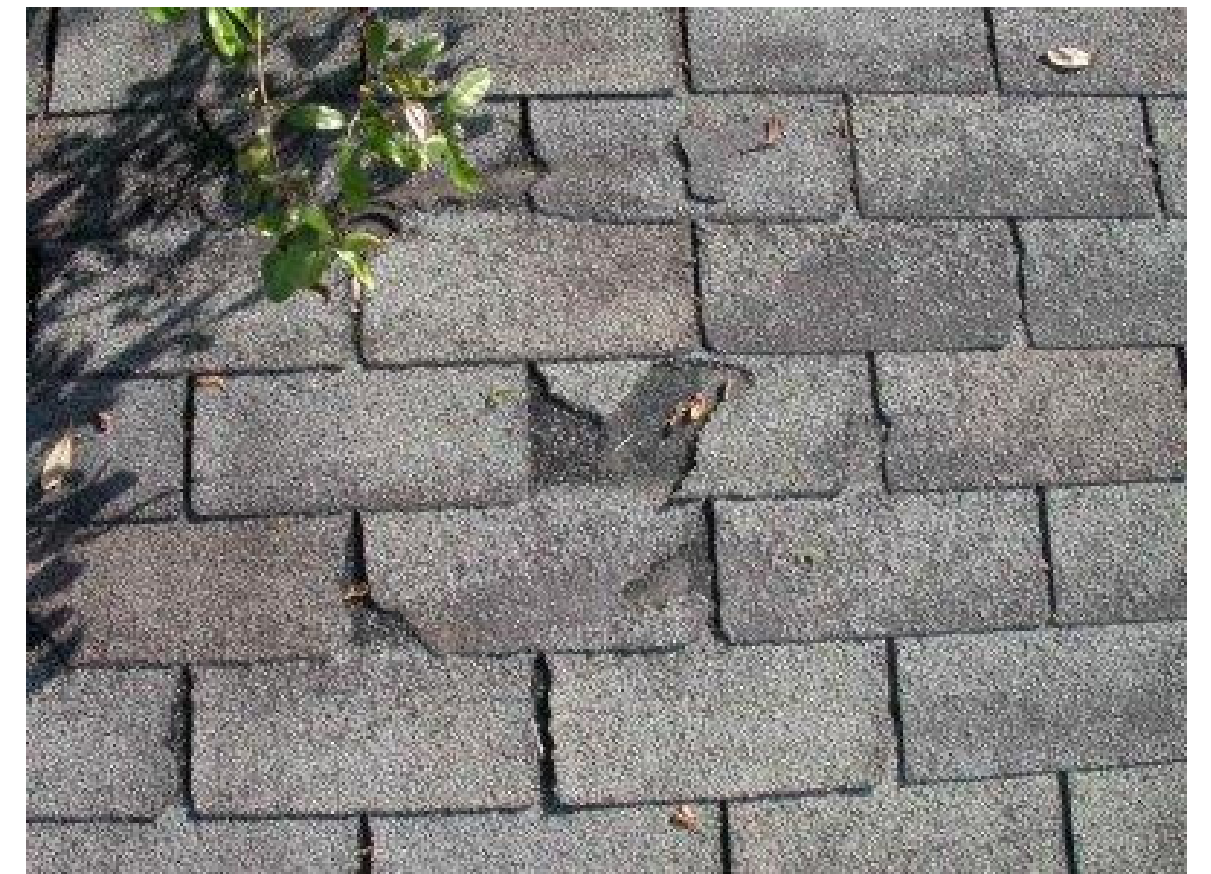
Above: a fiberglass asphalt shingle roof whose shingles became brittle over time, allowing the wind to get under them and blow them off the roof

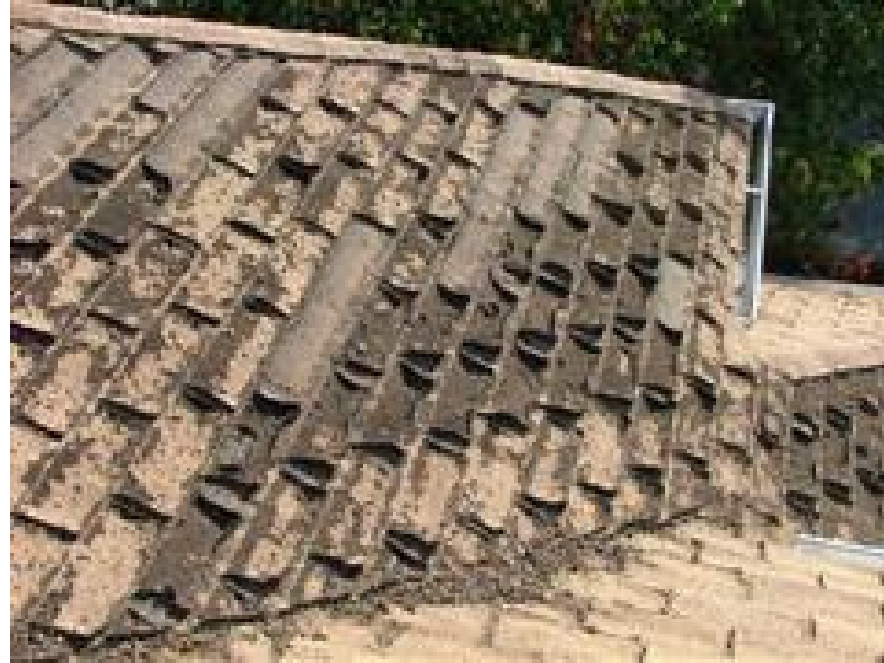
Above: an asphalt shingle roof that shows evidence of overheating, probably caused by both orientation and poor ventilation

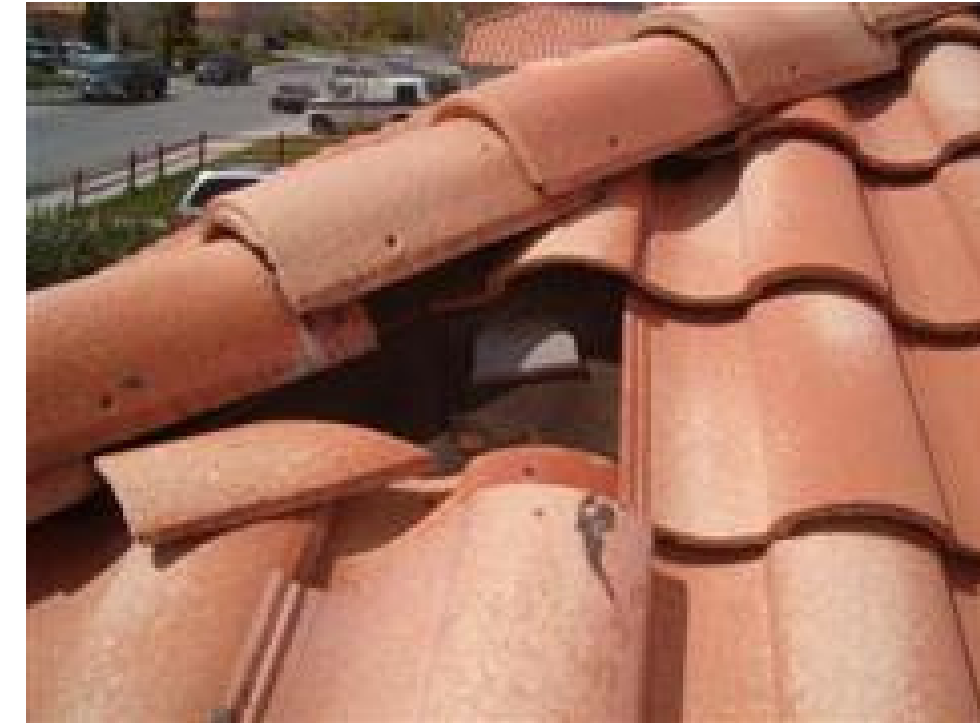
Above: impact damage on a clay tile roof showing broken and dislodged tiles

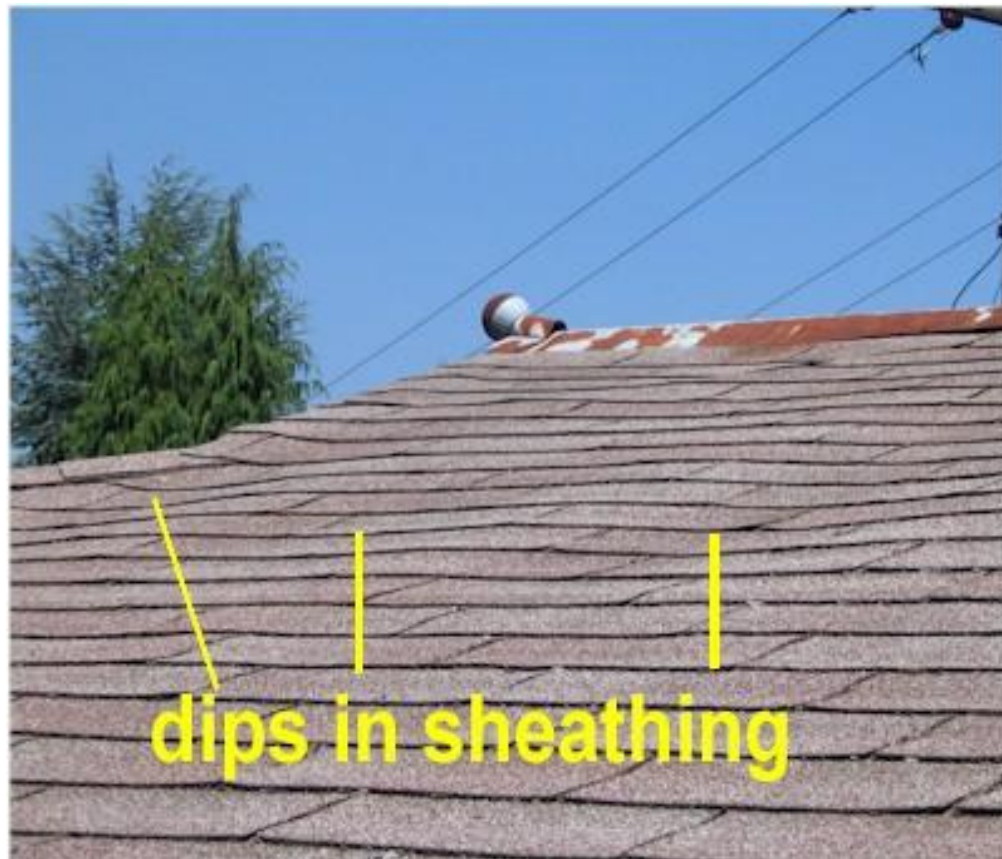
At left: visible dips due to de-laminating ply sheathing

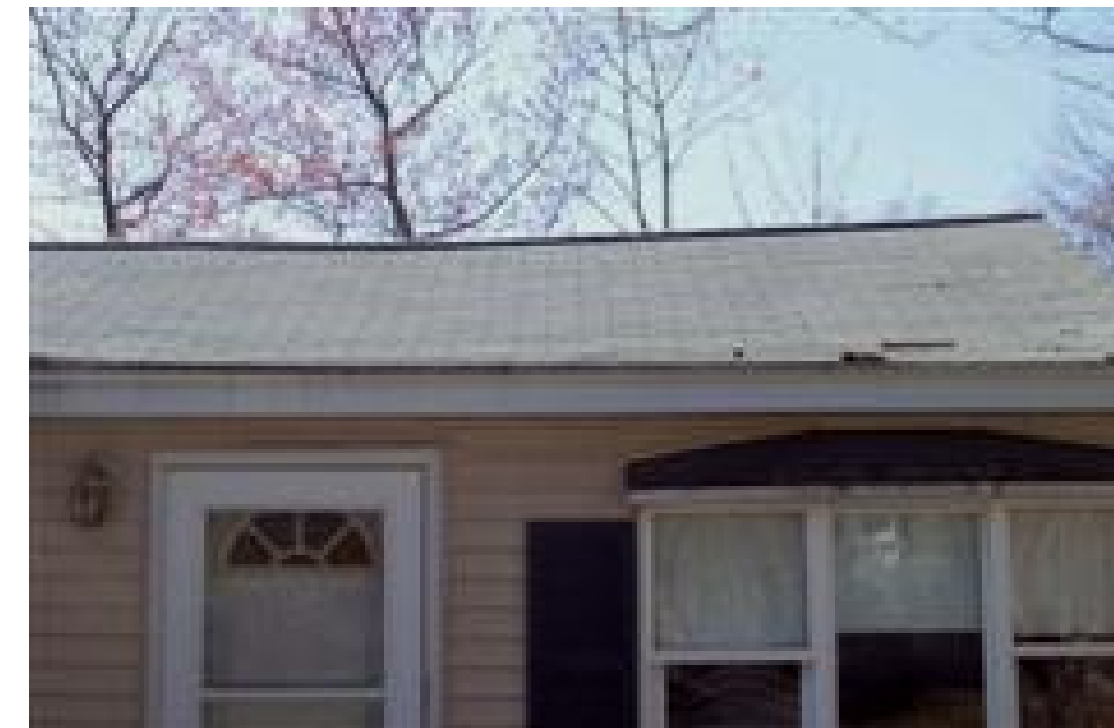
General Structural Inspection

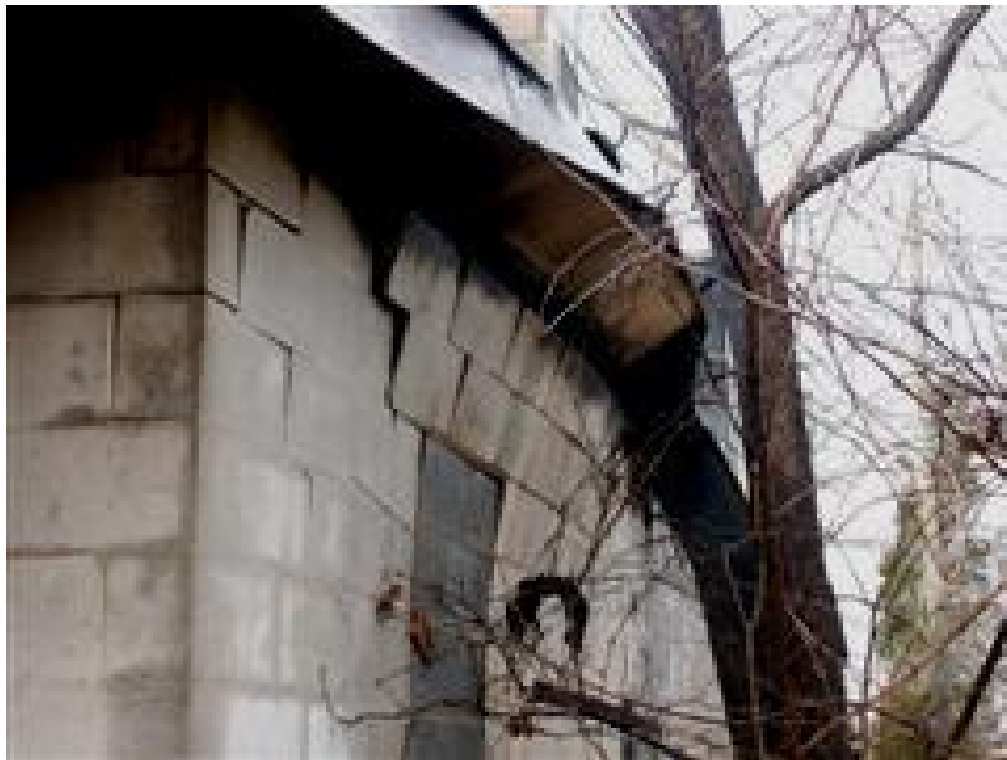
This wall (at left) was actually being pushed over after a fire had collapsed the roof. Visible at the top is rotation of the wall structure.

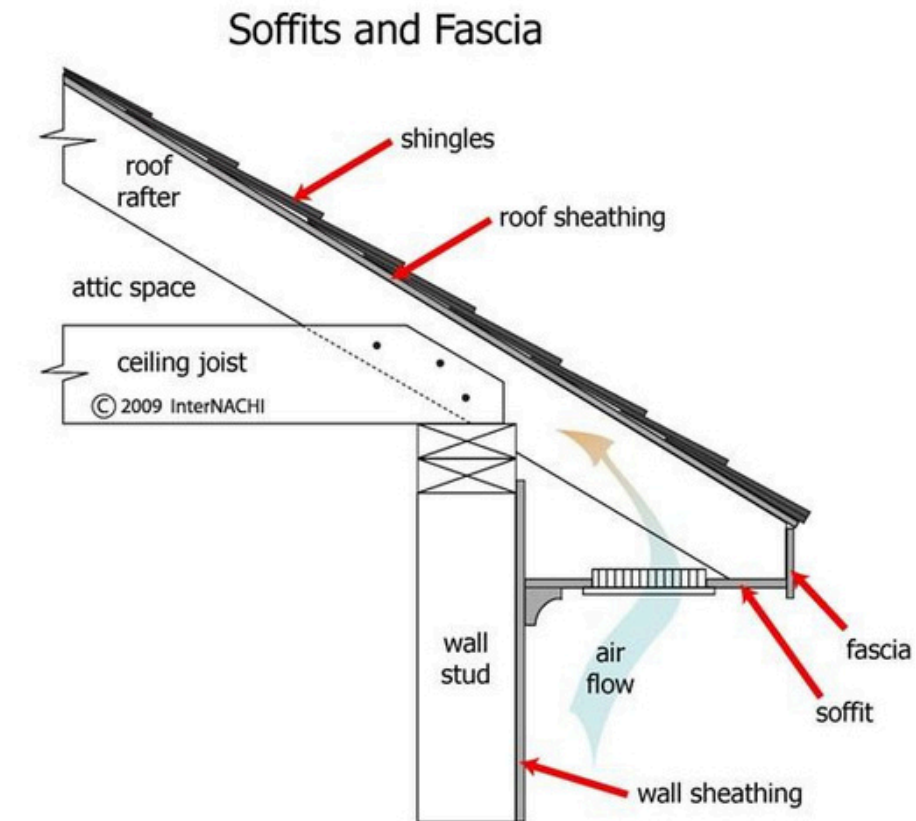
Rake or Barge Boards

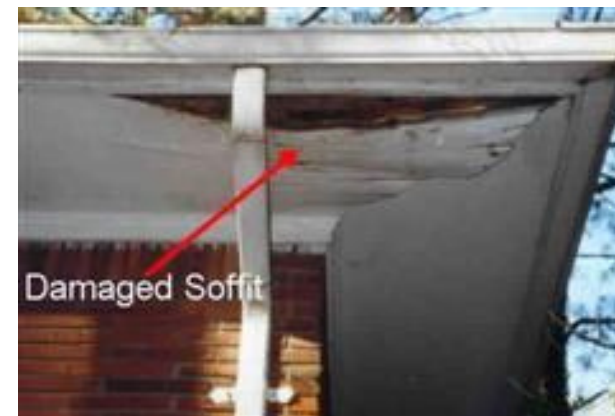
At left: standard box soffit showing signs of de-lamination due to moisture intrusion (Courtesy of Mike Rose)

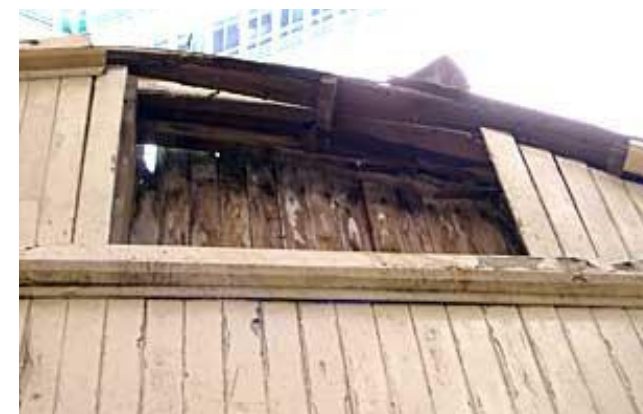
At left: older-style enclosed soffit clearly showing holes and missing boards, as well as signs of moisture in the roof sheathing

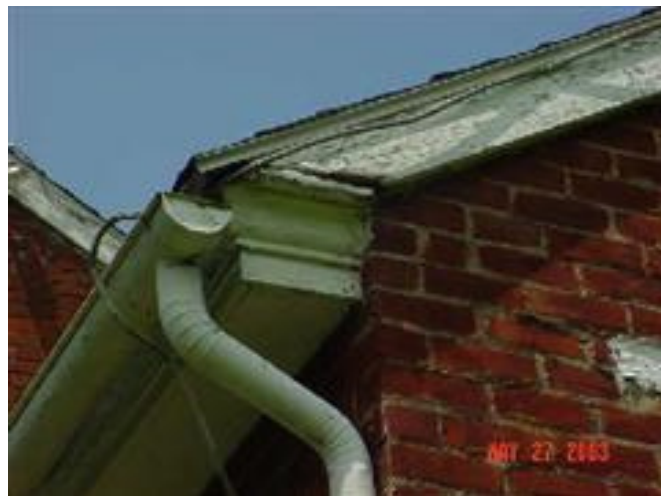
At left: rot in the lower part of the rake board; the wood has swollen and is pulling away.

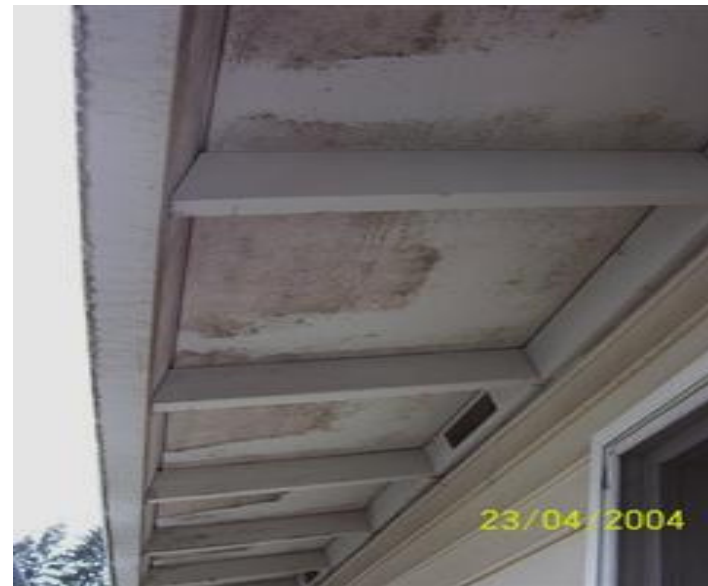
At right: open soffit with visible signs of moisture staining on the underside of the roof sheathing

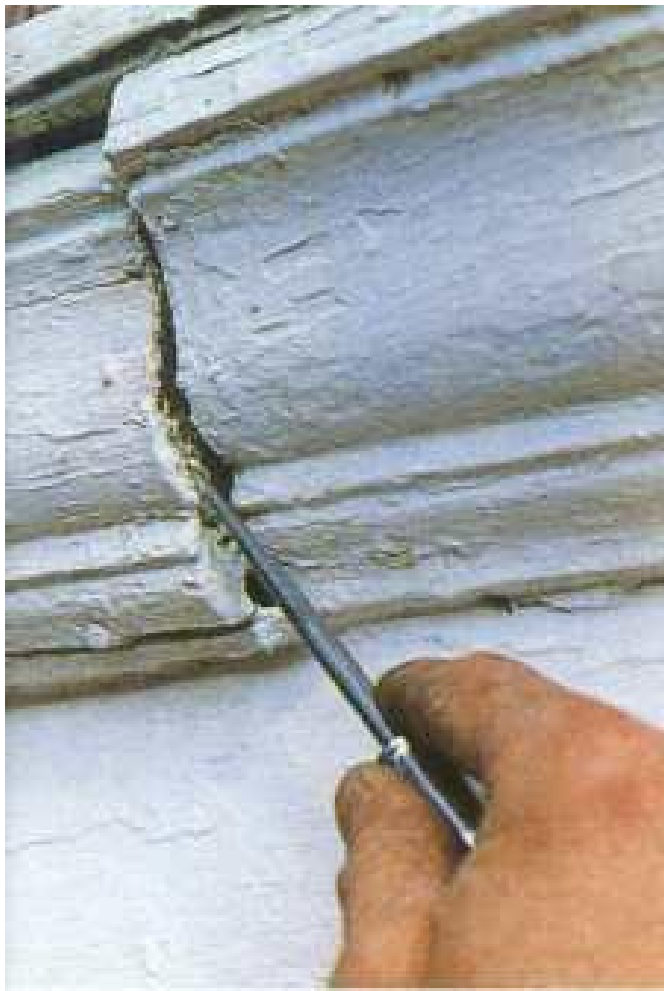
At left: Wood rot has loosened the cornice molding and is splitting around the nails.

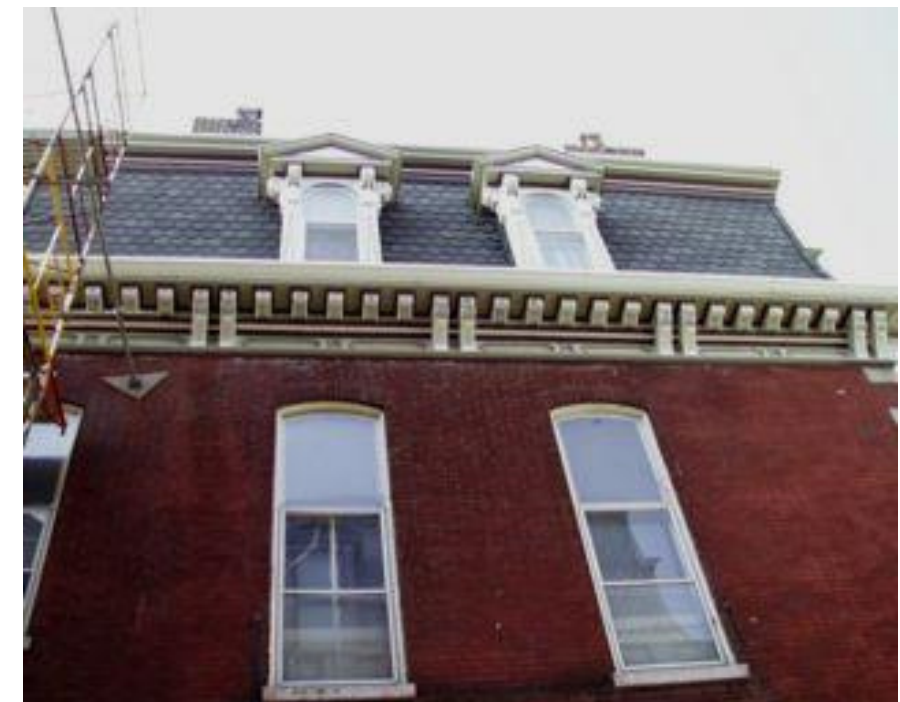
At right: an ornate cornice under a mansard roof with dentil molding

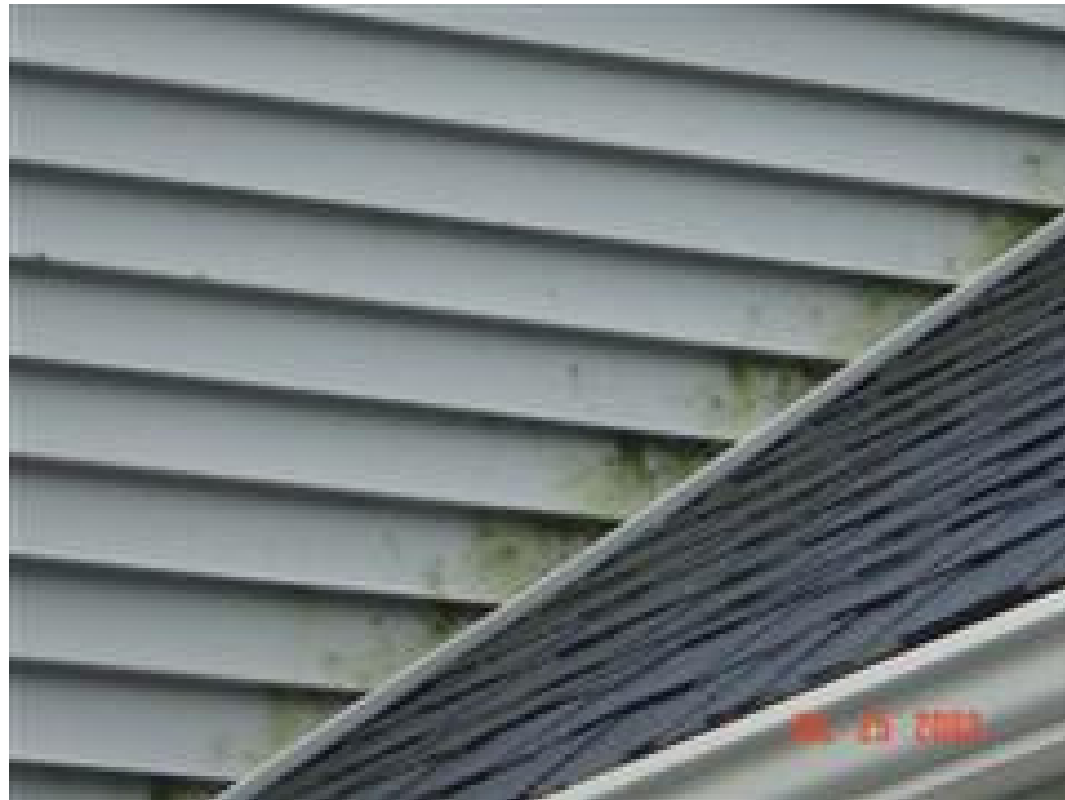
At left: Any trim that is this close to a roof's surface could potentially allow moisture to wick into the structure.

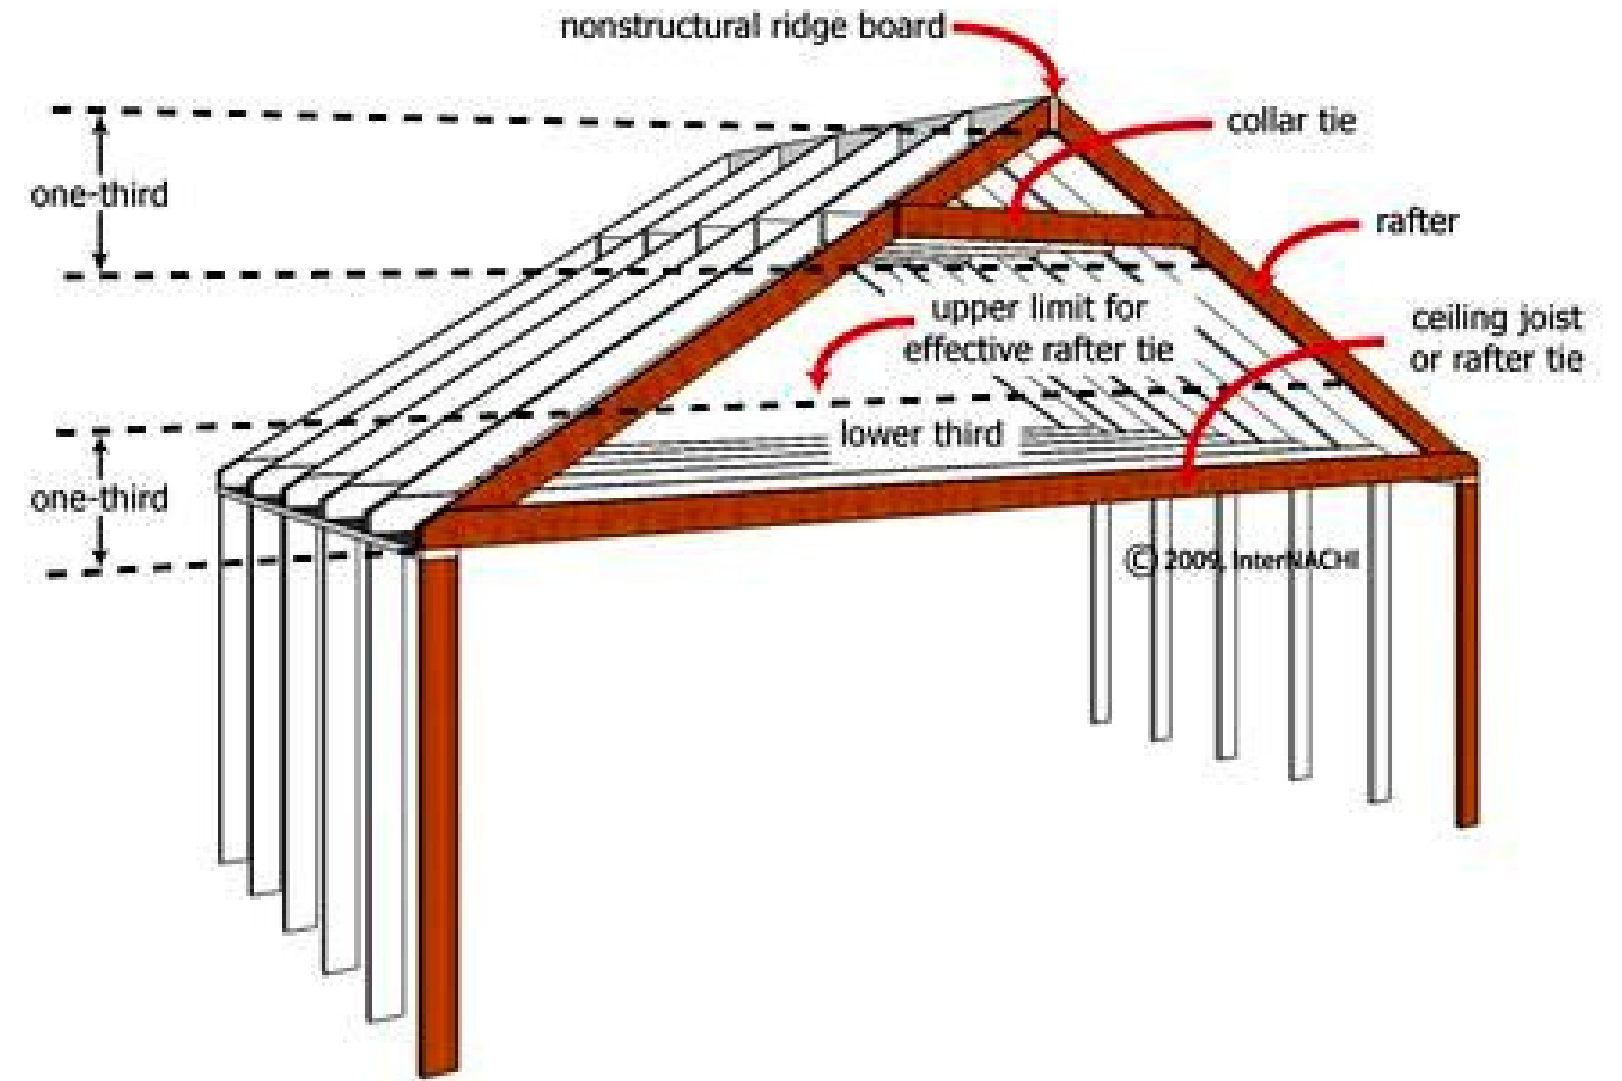
Although diagnosing the causes behind structural and cosmetic defects lies beyond the scope of a home inspector's duties, according to the InterNACHI Residential Standards of Practice, understanding some of those causes can help inspectors recognize certain defects more quickly so that he can report them and make appropriate recommendations to his clients.

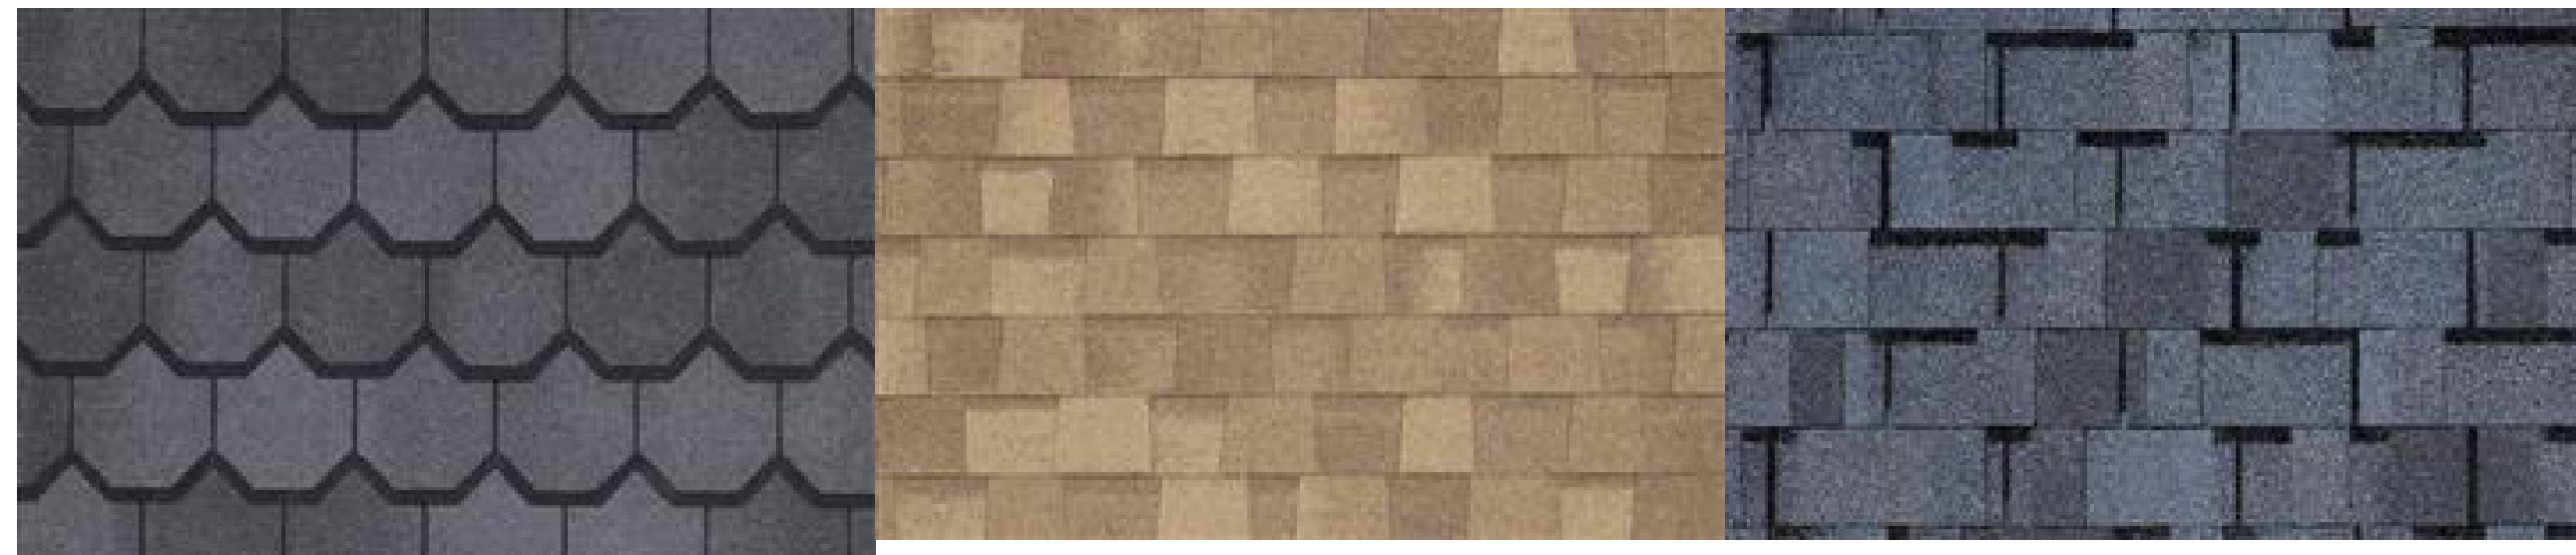
PROBLEMS WITH ASPHALT SHINGLES

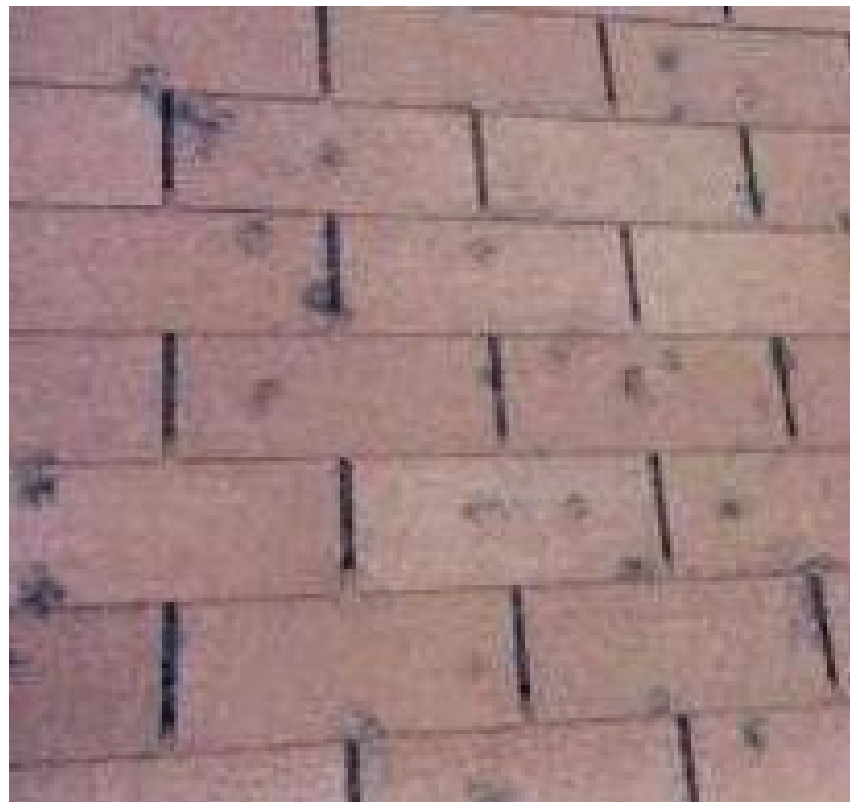
At left: a roof with visible hail damage

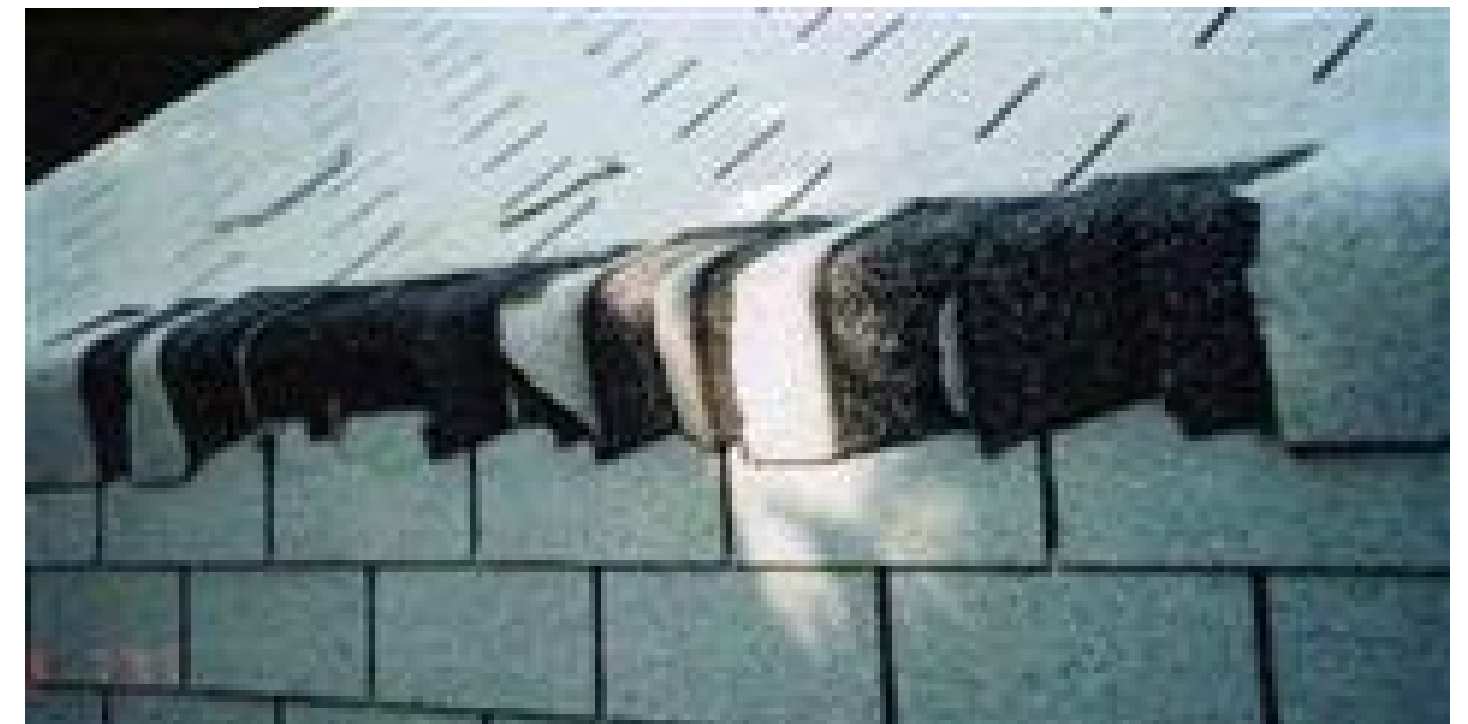
At right: Wind has blown off ridge shingles and damaged others.

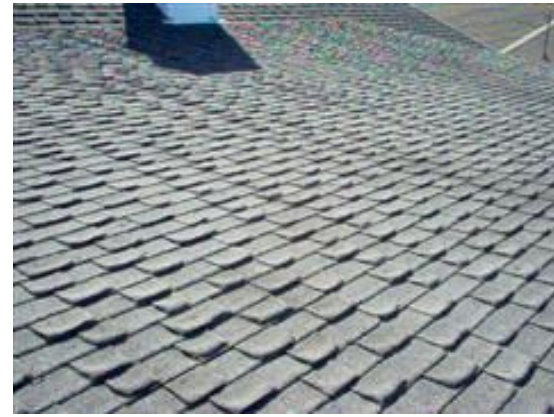
Above: Shingles overheated by the sun and/or poor ventilation are curling and cracking.

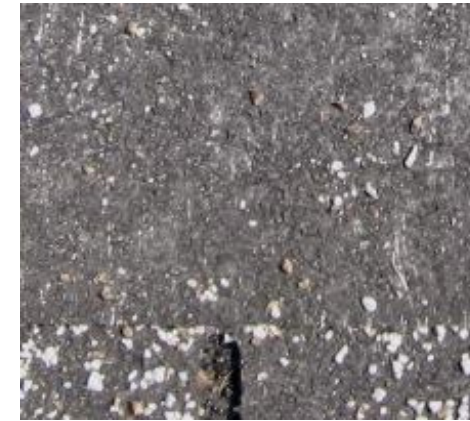
Above: an extreme close-up of a badly weathered fiberglass-based shingle whose fibers are exposed

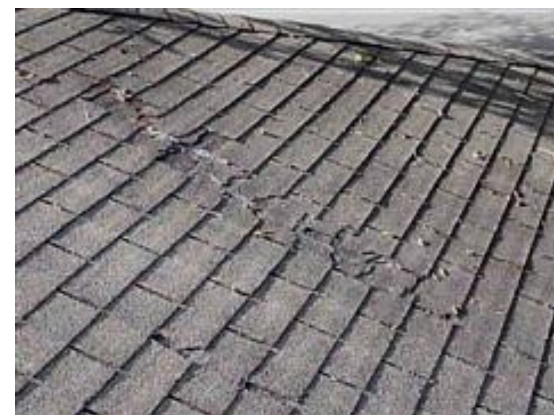
At left: another example of shingles that have been overheated by the sun and are now curling and cracking

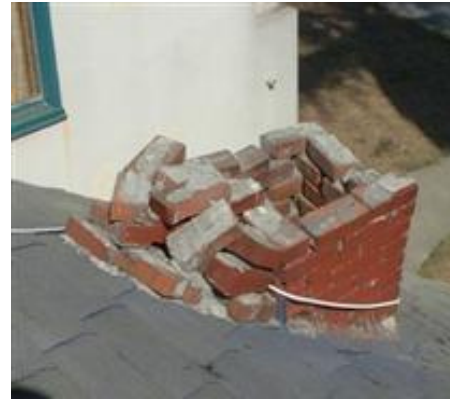
At left: A chimney has collapsed, damaging the shingles.

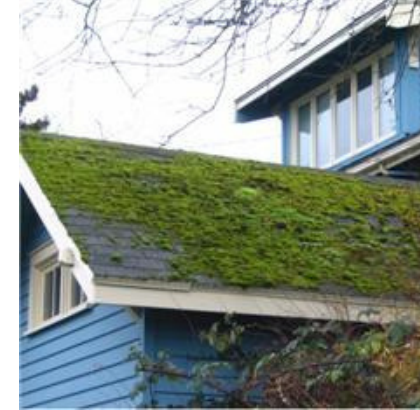
At right: A mossy roof is trapping moisture on the structure.

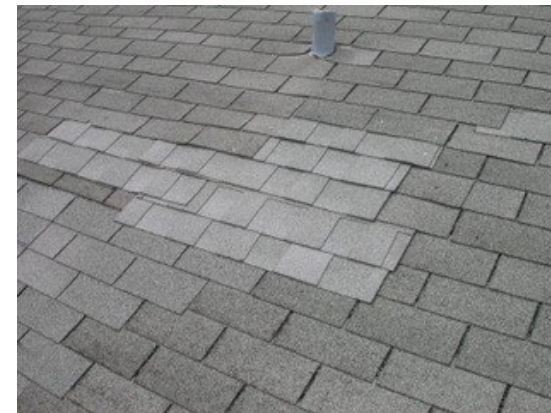
Above: Improper repairs have been made to this shingled roof.

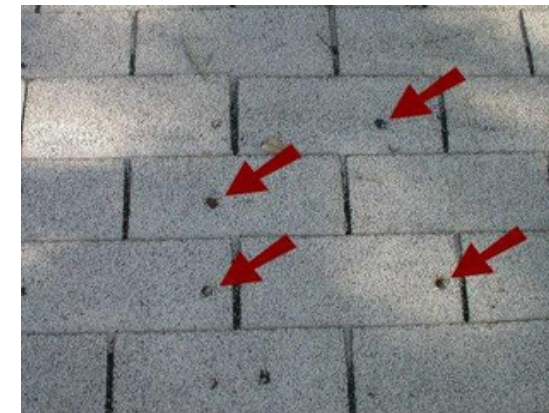
Above: Nail pops indicate where the fasteners have backed out of the roof.

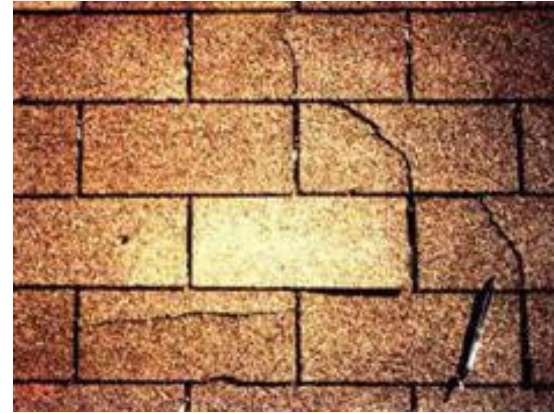
This kind of damage is typically seen on fiberglass-based shingle roofs.

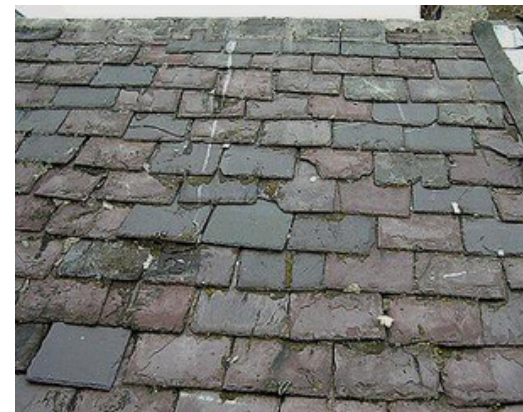
At left: an older slate installation showing many broken and dislodged tiles

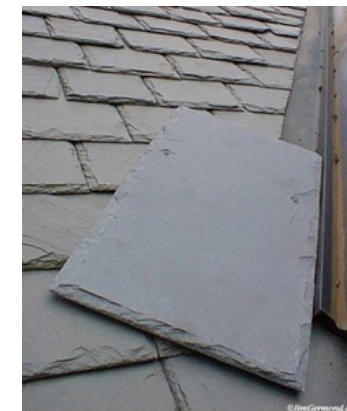
At right: a new slate roof; notice the crisp edges on the slate.
