ROOFER TRAINING

YOU NEED THESE 5 APPS

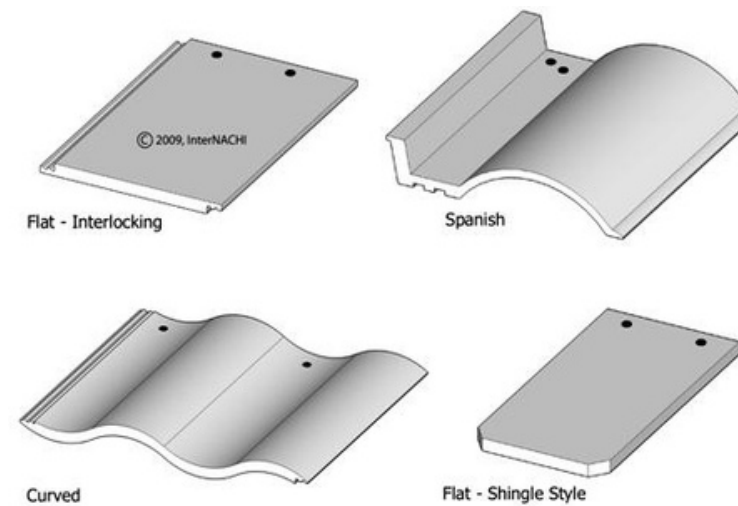
They are both made in similar sizes and shapes, such as flat, curved or corrugated, and may or may not be of an interlocking design. In most cases, tile designs are produced to be installed as ridge caps and used in other specialized locations.

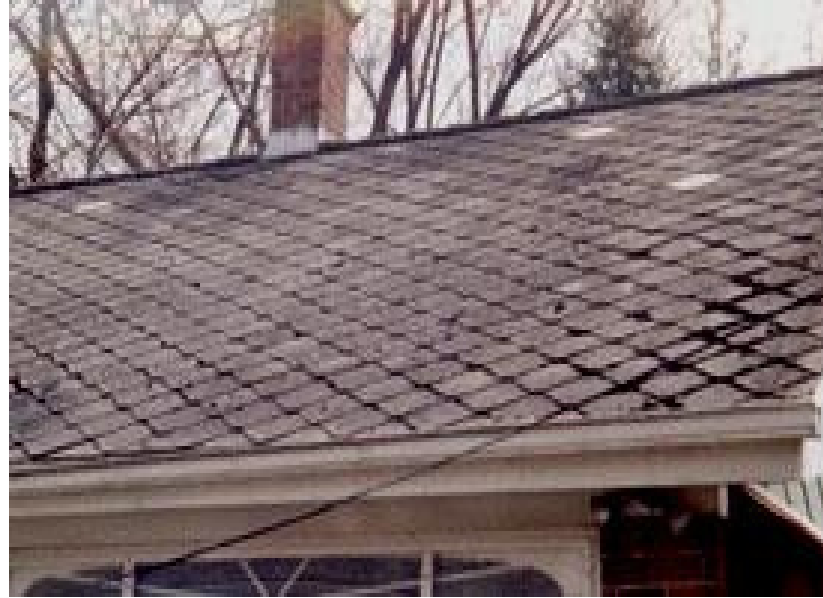
*Above: diamond-pattern asbestos
cement shingles*

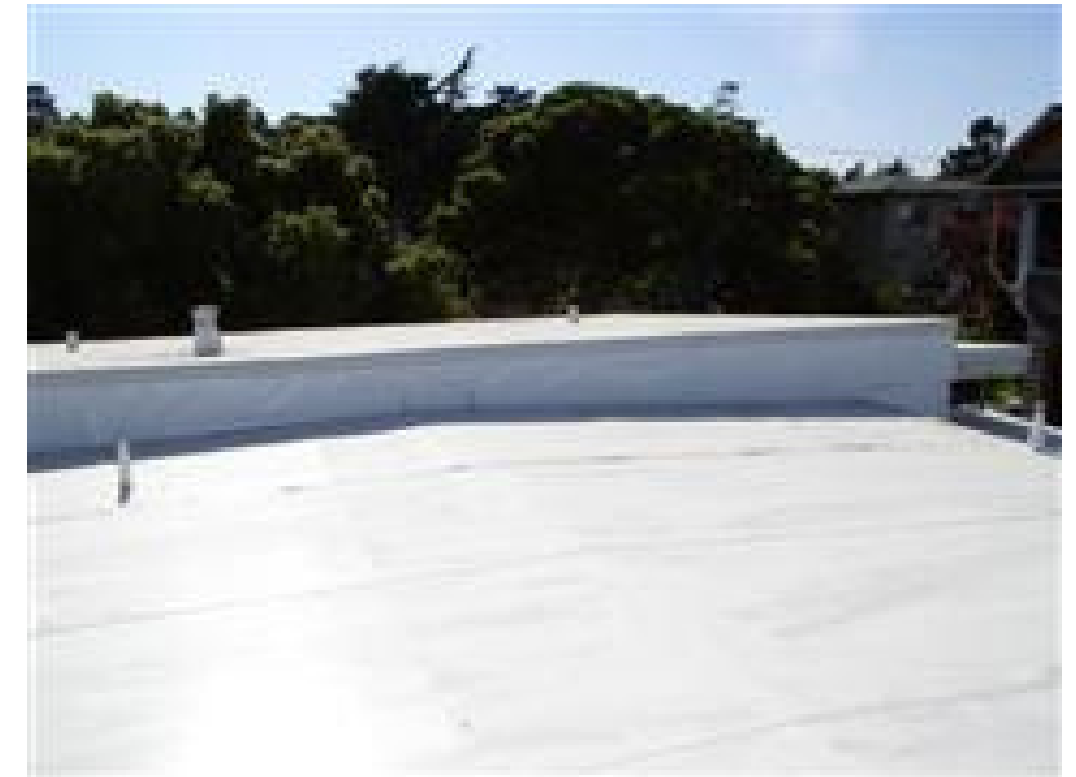
Above: This is another EPDM membrane. Notice the wrinkles between the sheets. This could easily allow water penetration. These areas need full evaluation.

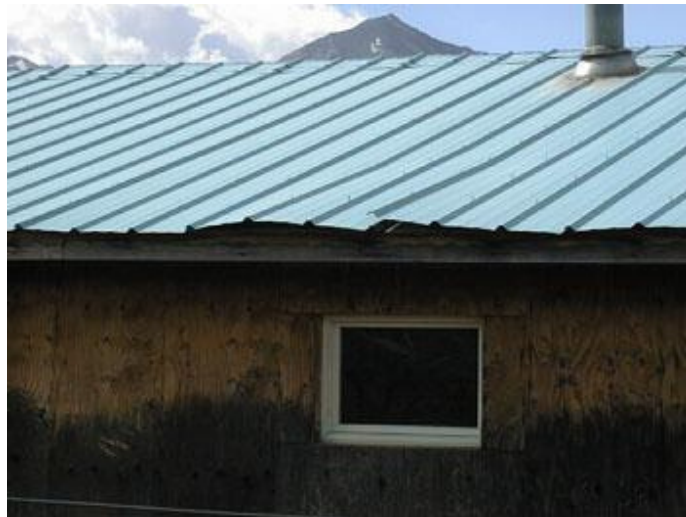
Above: This photo shows a standard corrugated steel roof (top-fixed). The panels have lifted, probably due to wind uplift and poor fastening.

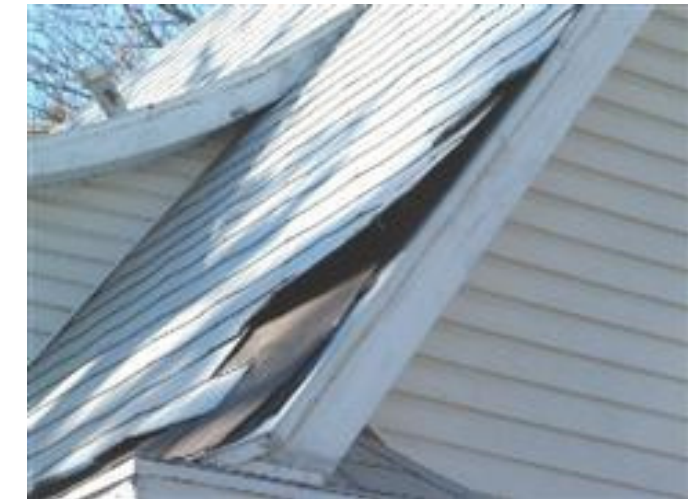
Above: This is an aluminum tile roof showing severe wind damage.

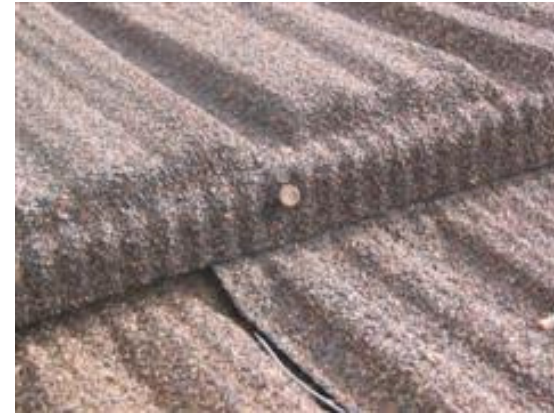
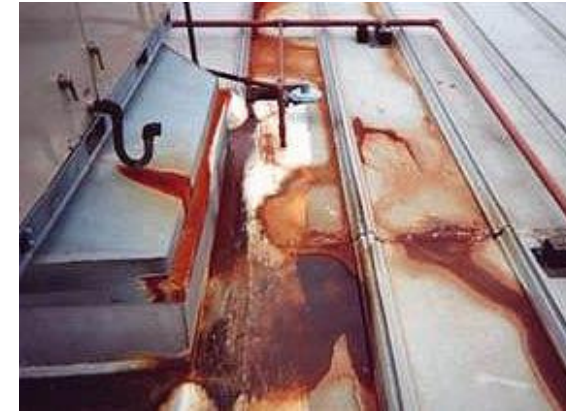
What to report for metal roofing:

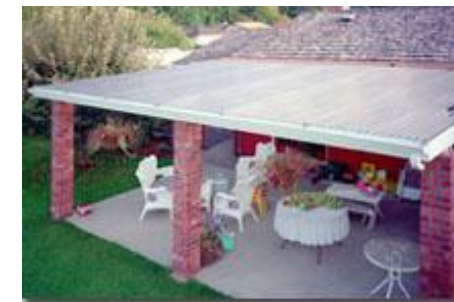
Nearly everyone has seen this material installed over a carport or homeowner-built lean-to. Obviously, any attempt to walk this type of roof is extremely unsafe.

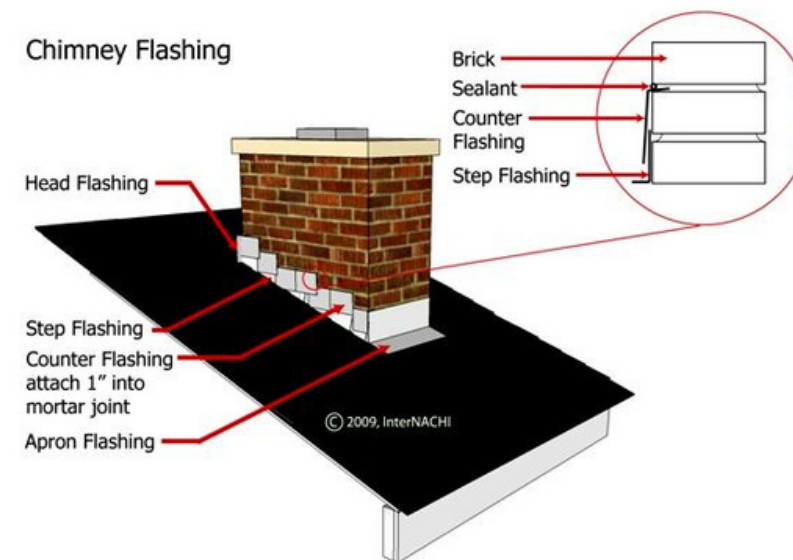
Apron flashings should be at the lowest face of the chimney, directing moisture away from the top-most edge of the shingles or tiles where they abut the chimney.

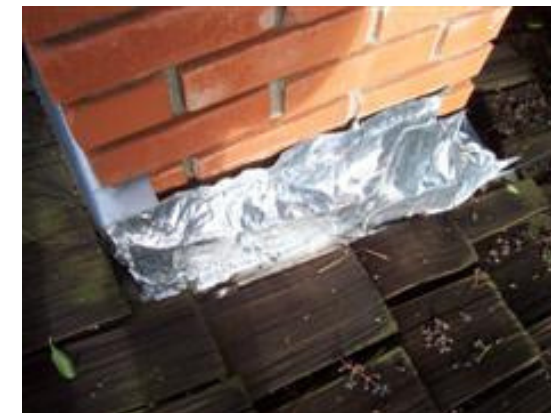
Above right: Tin foil used as a chimney flashing is useless and wrong.

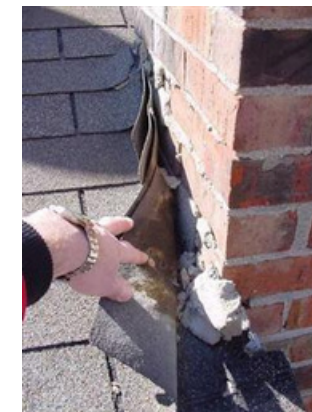
VENTS AND OTHER PENETRATIONS

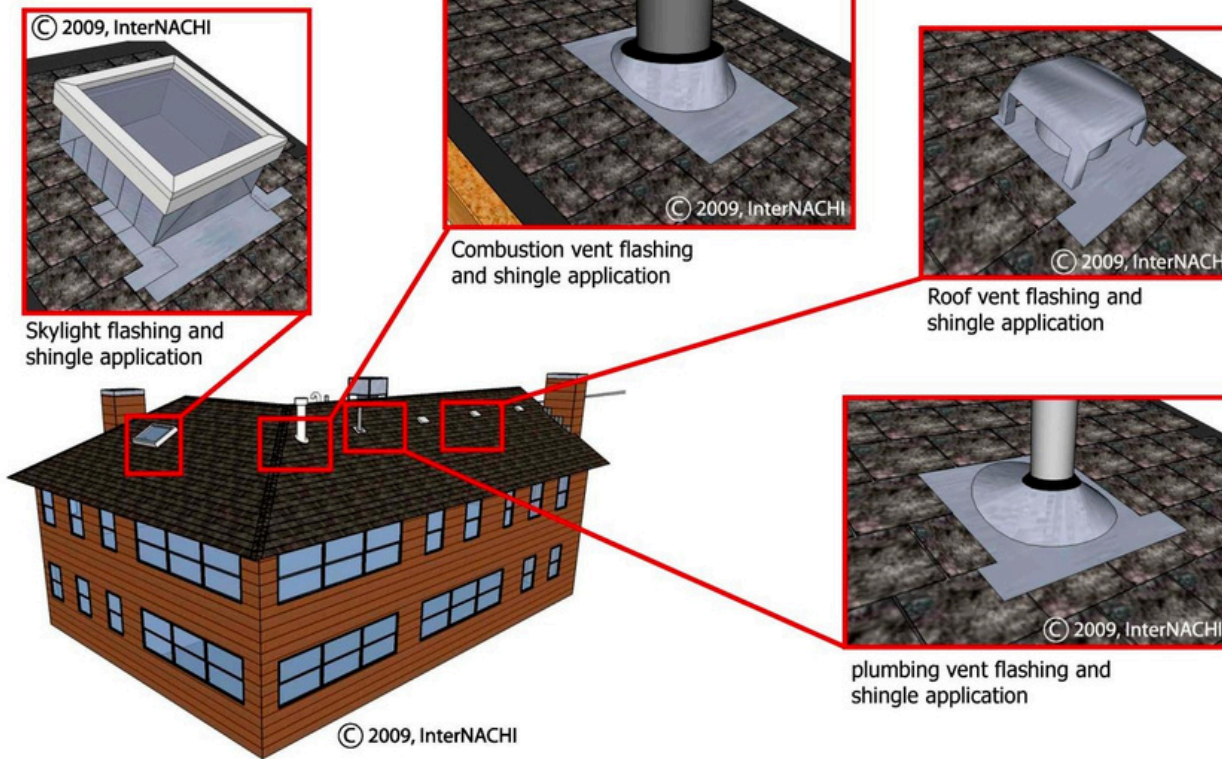
On any roofing system, the most common failures are those associated with any component that projects through the roof covering. In many cases where a roof has been re-covered, the original flashings have either been damaged or re-installed incorrectly, leading to leaks into the interior.

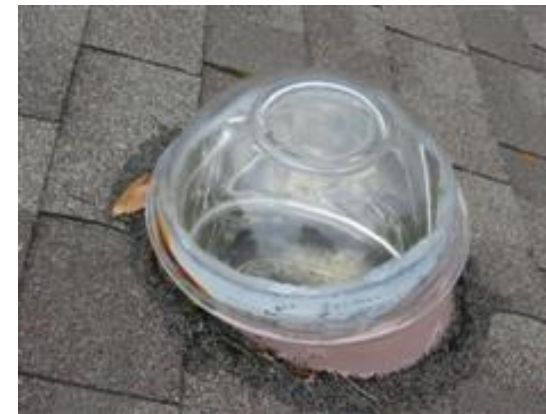
Through-the-roof dome lights, like the one pictured below, are most commonly retro-fitted and frequently cause leakage problems.

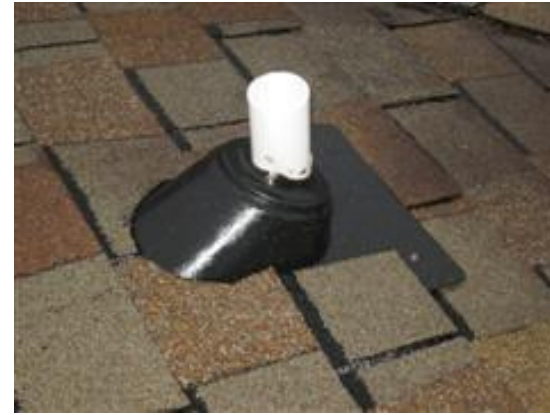
At left: This plastic vent flashing has been installed upside down. This will probably allow moisture to travel down the outside of the vent pipe.

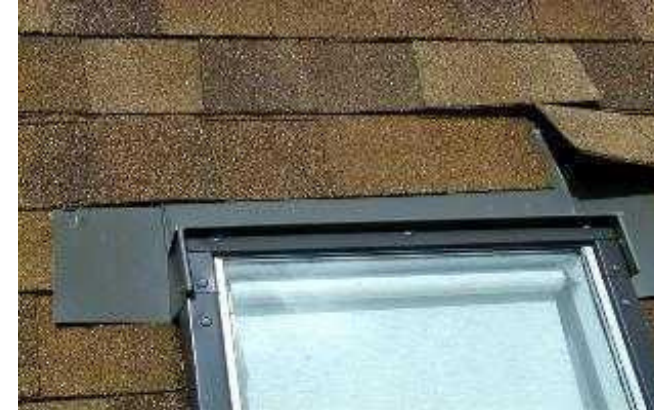
Below: This galvanized flashing has been installed improperly. The upper part of it should be under the shingles, and the roofing tar is a further sign of a poor repair.

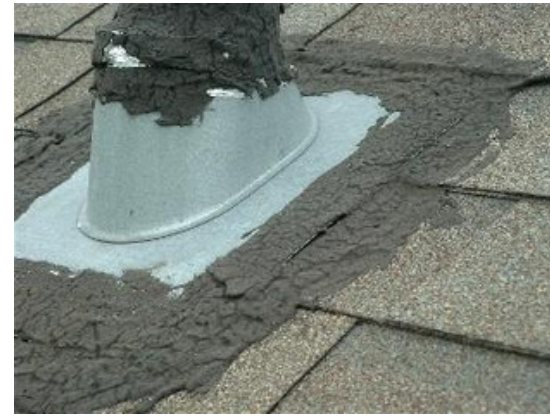
Below: A skylight in a metal roof shows damage to the roof on the top-side.

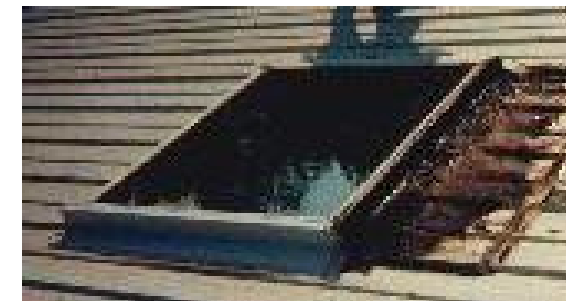
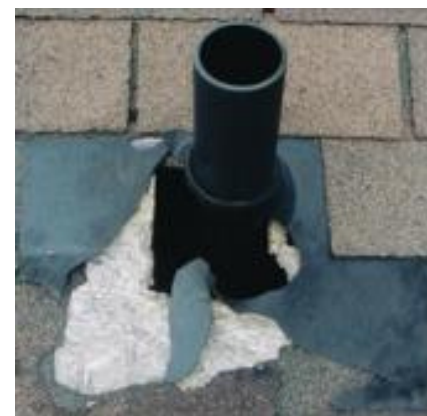
Above: This is a plastic vent flashing which was damaged by raccoons.

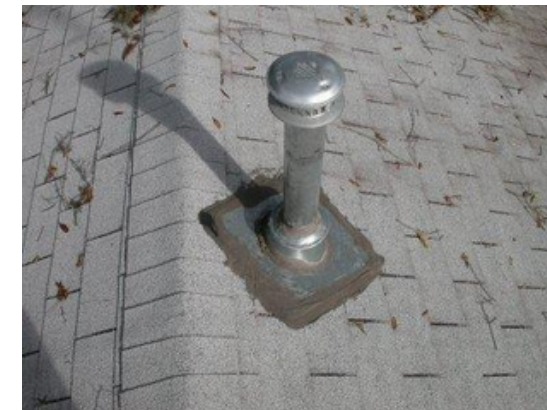
At right: This flashing has been improperly installed because the base should be underneath the shingles.

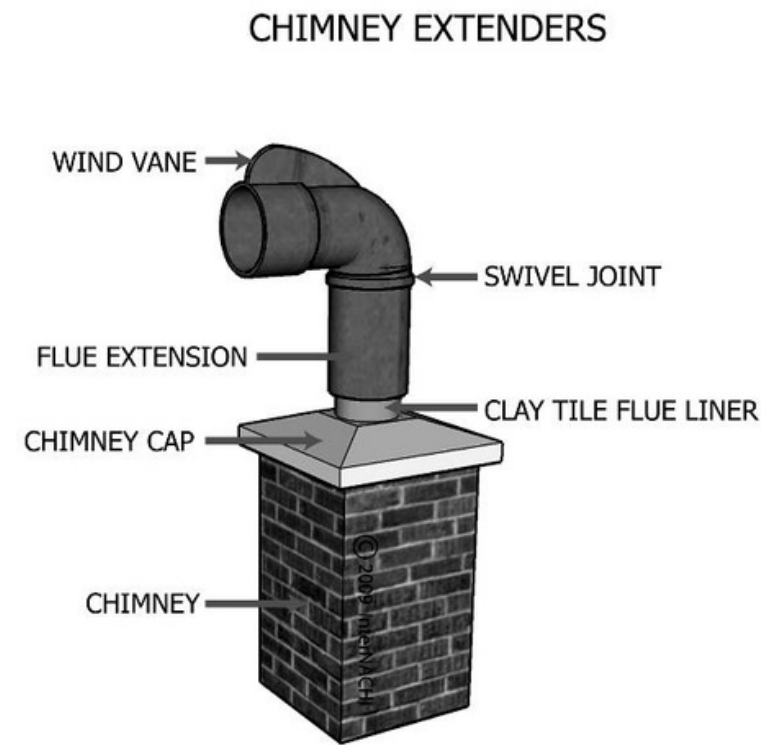
General Chimney Requirements

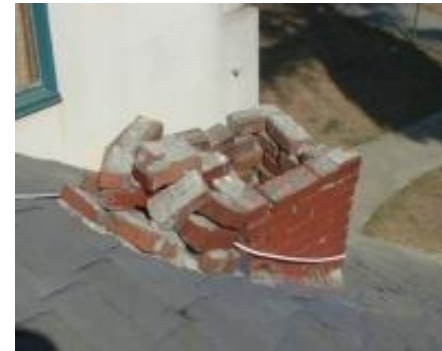
*Above: This chimney has not been maintained at all, leading to a full collapse.
(Courtesy of Jeff Pope)*

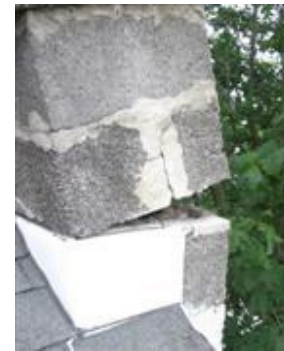
*Above: A block chimney is showing such severe cracking that the top three courses are completely loose.
(Courtesy of Joe Myers)*

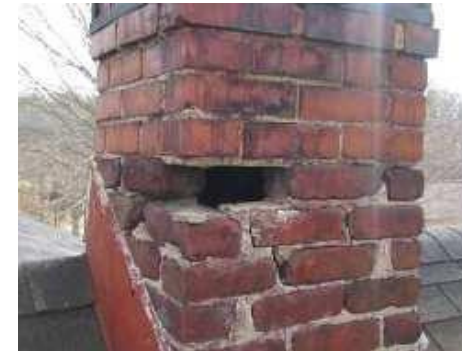
Above: A brick is missing and the mortar is spalling out.

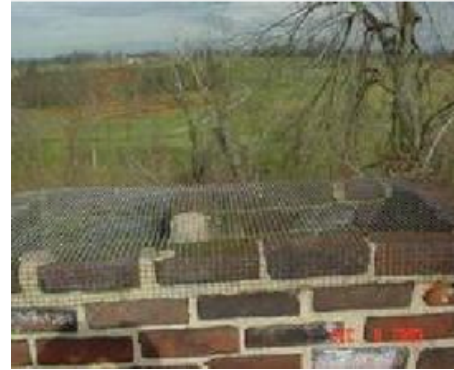
Above: This chimney has no cap or liner all. It is no longer legal to build an unlined chimney.

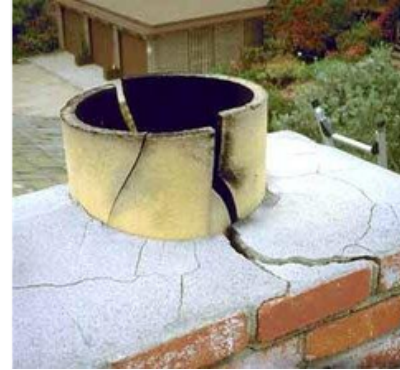
Above: Cracking can be seen both in the liner and in the chimney cap. This damage was caused by a flue fire.

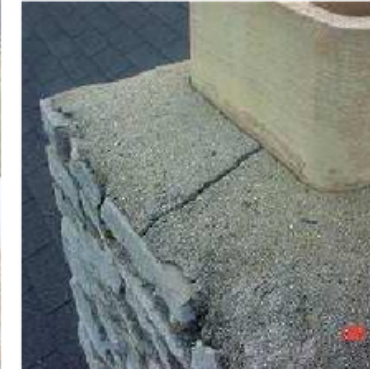
Above: cracking in the chimney cap

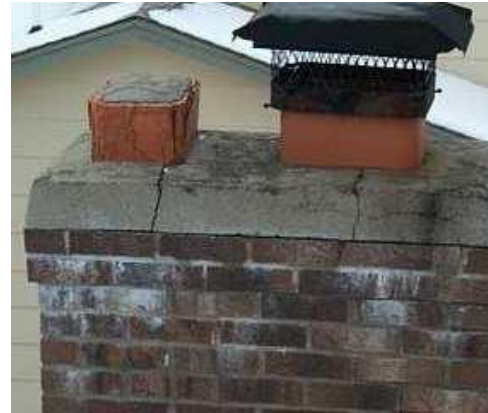
Above: The flue on the left has been sealed with concrete, and the flue on the right has a rain cap. However, the chimney cap itself is cracked and the brick work is showing signs of efflorescence.

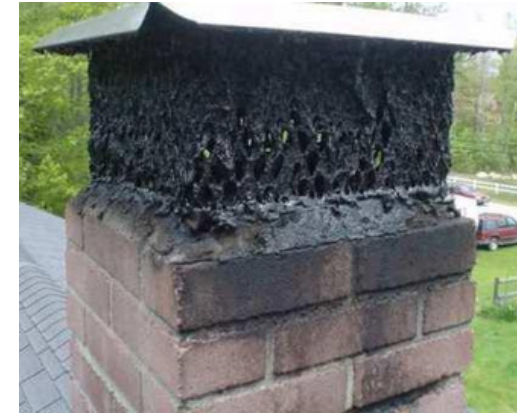
Above: This rain cap is completely choked with creosote, which is not unusual to find when the homeowner has been burning unseasoned timber.

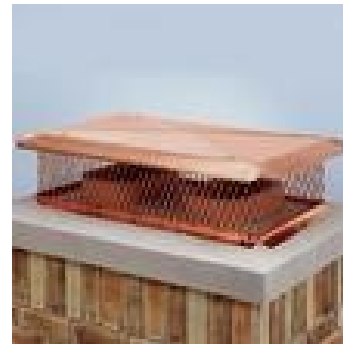
At left: A specially designed copper rain cap protects this double-flue chimney.

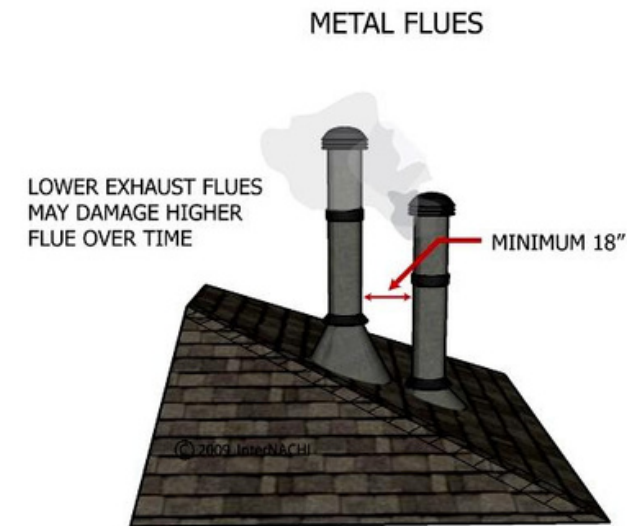
The term "manufactured chimney" generally relates to prefabricated chimney components, as opposed to a traditional chimney that would normally be manufactured from masonry products.

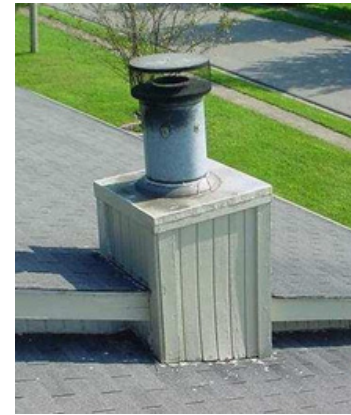
In this poorly designed chimney at left, there is no separation between the timber components and the roof, and there are a couple of dead areas which will trap moisture and promote rot.

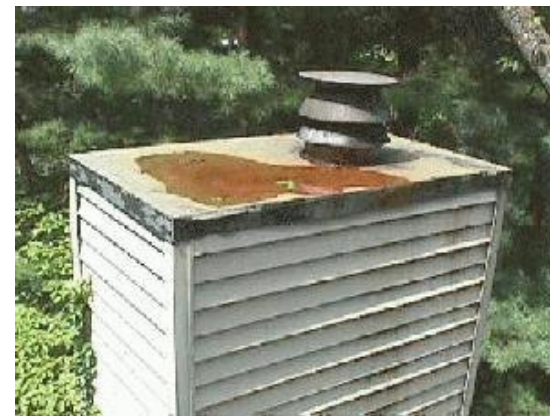
At left: Water is ponding on the top of the chimney cap. This will cause it to rot very quickly. Also note the lack of a proper drip edge.

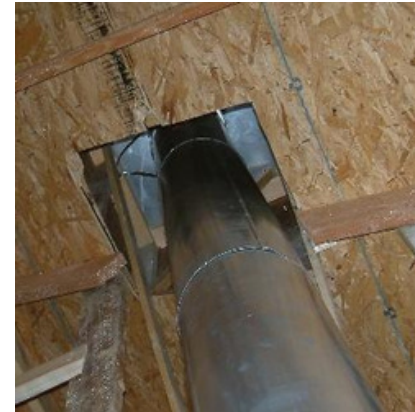
At left: This is a manufactured chimney going through the roof sheathing. The clearance on the right side is probably less than 2 inches. Also, notice how the rafter has been cut.

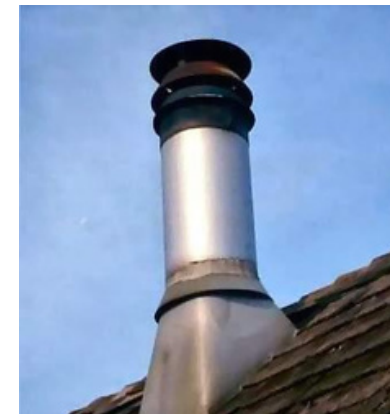
When inspecting manufactured chimney systems, the inspector should pay particular attention to:
